MISCELLANEOUS PAPER SL-80-6

**CONCRETE AND ROCK TESTS, MAJOR
REHABILITATION OF STARVED ROCK LOCK AND
DAM, ILLINOIS WATERWAY, CHICAGO DISTRICT
PHASE II COMPLIANCE, SCOUR DETECTION**

April 1980

Final Report

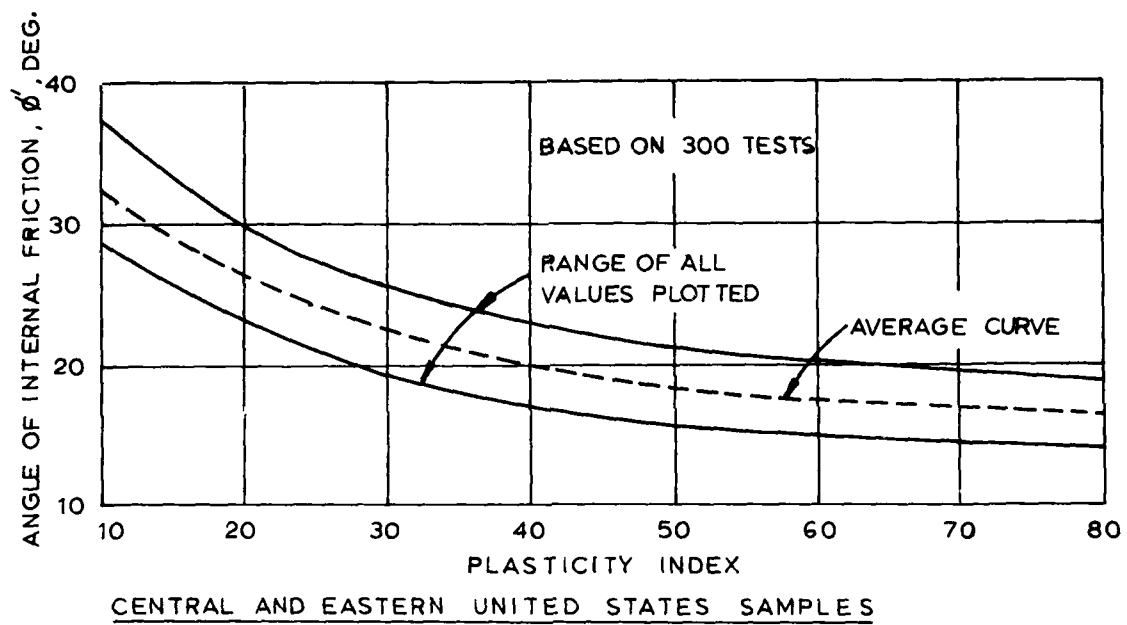
Figure 4. Correlation between ϕ' and plasticity index, from ETL 1110-1-58

to 26.5 deg. This range of phi values could be used in a stability analysis where relatively smooth clay-filled partings in the dolomite are considered.

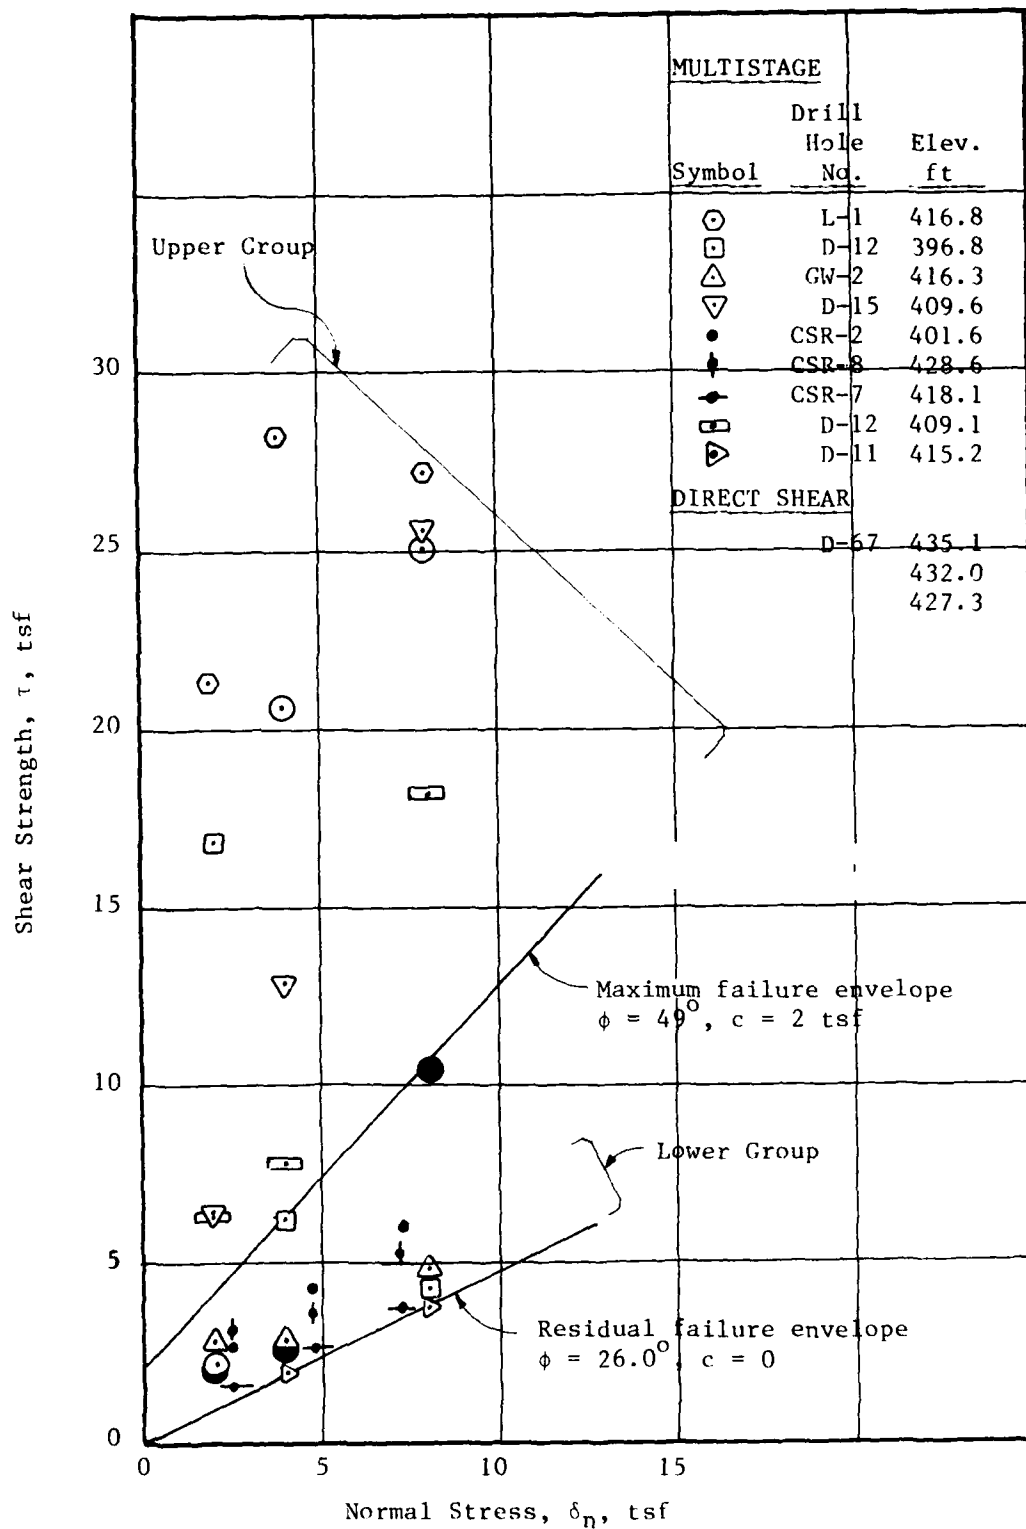
Figure 5. Direct shear results, shale-filled parting in dolomite, Starved Rock Lock and Dam

76. In Figure 5 the lower grouping of repetitive test results represent the residual shear strength (ϕ_r) for shale-filled partings in dolomite; the $\phi_r = 26$ deg and $c = 0$. A series of direct shear tests was conducted, and the peak and residual stress values are represented in Figure 5 by the open and solid circles. The residual stress values were obtained by repositioning the shear blocks after the initial shear was recorded, reapplying the same normal stress, and reshearing the specimens. Each specimen was resheared from two to four times. The residual shear stress obtained from the specimens tested at 2- and 4- tsf normal load plot well within the lower group of repetitive test results. The residual stress value obtained from the specimen tested in direct shear at $\delta_n = 8$ tsf is outside the lower group. However, this is not surprising considering the different specimens available for testing.

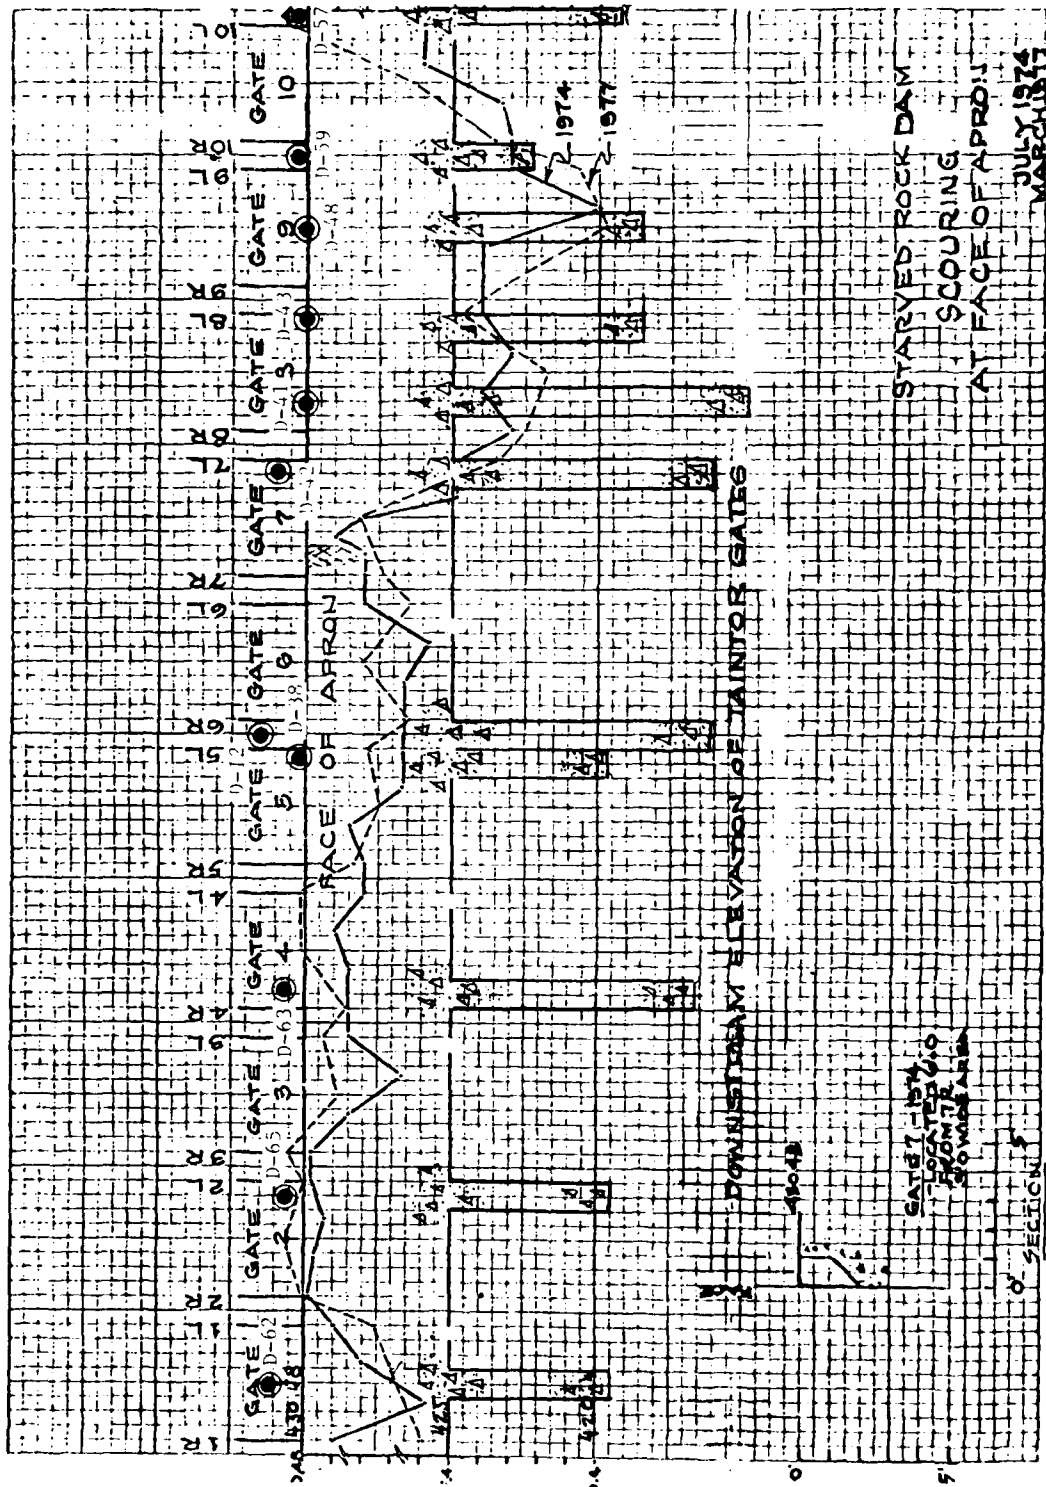
Figure 6. Scouring at face of apron

Figure 6 shows the scouring at the face of the apron in the taintor gate dam as plotted by NCC. Superimposed on this graph are the actual base elevations of concrete at boring locations given in the above tabulation. Figures 7, 8, and 9 show the scouring at the apron face in the head gate dam. These figures illustrate the base elevation of the concrete as

revealed in borings. Indications are that the 1977 scouring has not undercut the apron for the full length of the two dam sections. The base elevation of the taintor gate dam section is variable, and extrapolation of these actual base elevations to other sections of the taintor gate should be done with caution. The head gate dam appears to have been built using two different design criteria. The first 16 gate bays are founded on weakly cemented and friable sandstone, the 17th pier founded on a shale seam, while the remaining gate bays appear to be founded on competent dolomite. Because of the variable foundation elevations in the head gate dam section, extrapolation of foundation elevations to other sections of the head gates, notably bays 17 through 30, could be misleading. It is suggested that an NX boring be put through the bays already not drilled to determine actual base elevations. A figure for the ice chute is not presented. The one boring in the ice chute overflow section shows the base of concrete at el 419.5 ft; working drawings indicate the base of this structure to be el 430.0 ft.
